**Flood Control Project Maintenance  
Levee Inspections**

## Maintenance Issue Types Only, Levee Inspection Report By Mile - Spring 2018

### Reclamation District No. 0501 Ryer Island

Waterway	Bank	Unit Miles	Inspection Start/End	Inspector
Unit No. 01 Steamboat Slough	Right	6.71	03/13/2018 03/13/2018	Keith Millard

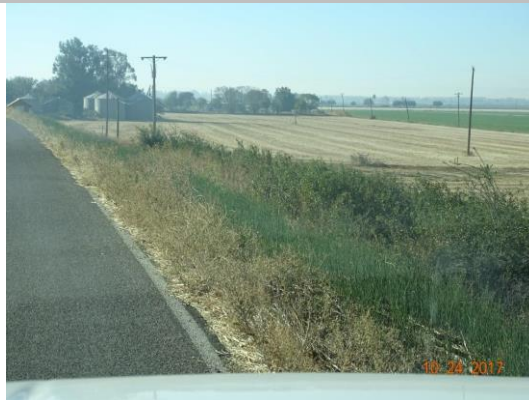
Photo 1 of 1 : SP\_2018\_RD0501\_169\_28\_20180305\_00005.jpg

LM Start	0.31	Rating **	A/W	Issue No.	28
LM End	0.31	Issue Type +	Ma	Location *	LS
Category	Earthen Levee			GPS Latitude/Longitude	
				Start	End
Item	Trim / Thin Trees			38.250340 °	38.250340 °
				-121.603133 °	-121.603133 °
DWR ID	DWR_RD0501_01_f_2017_28				
Comment Code					
T2 : Thin trees to allow visibility of the ground and room to flood fight.					
Inspector Comment					
Trim trees at landside toe to allow inspection and access.

Trim trees at landside toe to allow inspection and access.

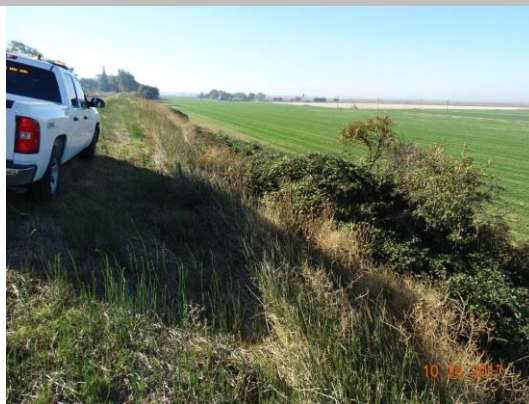
Photo 1 of 1 : SP\_2018\_RD0501\_169\_29\_20180305\_00006.jpg

LM Start	0.76	Rating **	M	Issue No.	29
LM End	1.01	Issue Type +	Ma	Location *	LS
Category	Earthen Levee			GPS Latitude/Longitude	
				Start	End
Item	Vegetation			38.243815 °	38.240257 °
				-121.603077 °	-121.603873 °
DWR ID	DWR_RD0501_01_f_2017_29				
Comment Code					
V2 : Remove the wild growth other than native grasses from the levee slopes.					
Inspector Comment					
Landside slope is covered in blackberry vines. Should be removed to allow inspection and access.

Landside slope is covered in blackberry vines. Should be removed to allow inspection and access.

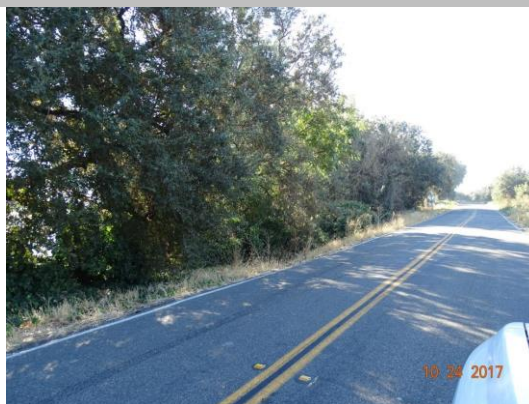
Photo 1 of 1 : SP\_2018\_RD0501\_169\_31\_20180305\_00008.jpg

LM Start	1.01	Rating **	M	Issue No.	31
LM End	1.11	Issue Type +	Ma	Location *	WS
Category	Earthen Levee			GPS Latitude/Longitude	
				Start	End
Item	Vegetation			38.240222 °	38.238918 °
				-121.603887 °	-121.604338 °
DWR ID	DWR_RD0501_01_f_2017_31				
Comment Code					
V2 : Remove the wild growth other than native grasses from the levee slopes.					
Inspector Comment					
Waterside vegetation should be thinned/removed to 20' from crown to allow inspection and access.

Waterside vegetation should be thinned/removed to 20' from crown to allow inspection and access.

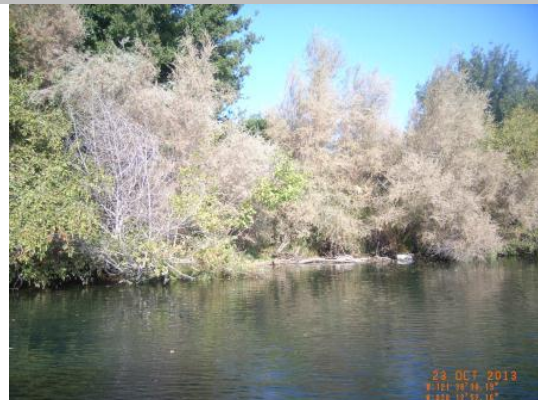
Photo 1 of 1 : SP\_2018\_RD0501\_169\_3\_20180305\_00003.jpg

LM Start	2.85	Rating **	M	Issue No.	3
LM End	2.91	Issue Type +	Ma	Location *	WS
Category	Supplemental			GPS Latitude/Longitude	
				Start	End
Item	2015 USACE Erosion Survey, DRAFT			38.214838 °	38.214075 °
				-121.608129 °	-121.608750 °
DWR ID	DWR_RD0501_01_f_2016_3				
Comment Code					
Inspector Comment					
2009 - Rock is starting to unravel, probably from a tree pop-out, hard toe. 2015: No observed changes. [2015 Site ID: STM_18-9_R]

USACE 2013 Photo #1

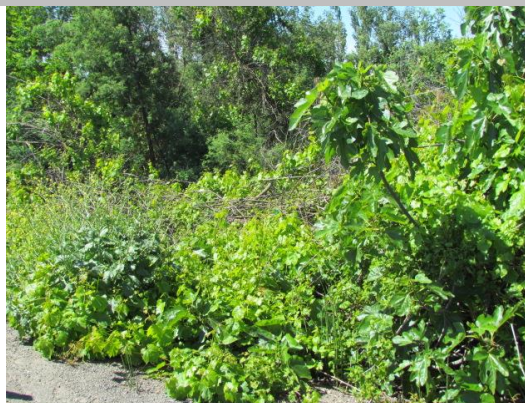
Photo 2 of 2 : SP\_2018\_RD0501\_169\_974\_20180305\_00016.jpg

LM Start	3.73	Rating **	A/W	Issue No.	974 (cont)	
LM End	4.12	Issue Type +	Ma	Location *	WS	
Category	Earthen Levee			GPS Latitude/Longitude		
				Start		End
Item	Vegetation			38.202997 °		38.197778 °
				-121.613450 °		-121.616080 °
DWR ID	DWR_RD0501_01_s_2012_974					
Comment Code						
V2 : Remove the wild growth other than native grasses from the levee slopes.						
Inspector Comment						
Vegetation has been cleared to 20 feet from crown.

RD 501 Levee mile 3.73-4.12 wild tree growth and vegetation blocking view of the levee slope.

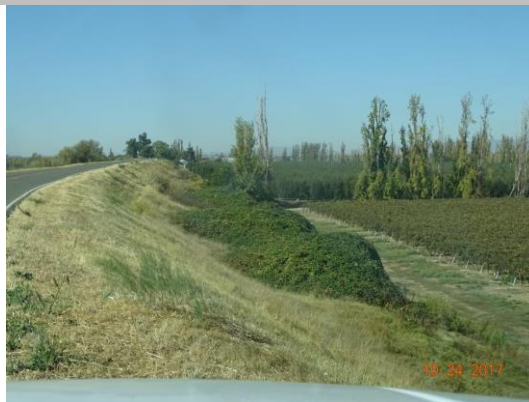
Photo 1 of 1 : SP\_2018\_RD0501\_169\_35\_20180305\_00009.jpg

LM Start	4.64	Rating **	M	Issue No.	35
LM End	4.64	Issue Type +	Ma	Location *	LS
Category	Earthen Levee			GPS Latitude/Longitude	
				Start	End
Item	Vegetation			38.194463 °	38.194463 °
				-121.624310 °	-121.624310 °
DWR ID	DWR_RD0501_01_f_2017_35				
Comment Code					
V2 : Remove the wild growth other than native grasses from the levee slopes.					
Inspector Comment					
Very large mounds of blackberry vines prohibit inspection and access. Should be removed.

Very large mounds of blackberry vines prohibit inspection and access. Should be removed.

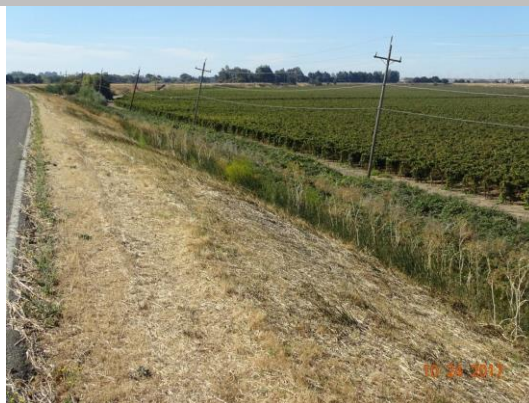
Photo 1 of 1 : SP\_2018\_RD0501\_169\_39\_20180305\_00011.jpg

LM Start	5.94	Rating **	M	Issue No.	39
LM End	6.15	Issue Type +	Ma	Location *	LS
Category	Earthen Levee			GPS Latitude/Longitude	
				Start	End
Item	Vegetation			38.188283 °	38.186090 °
				-121.645398 °	-121.648027 °
DWR ID	DWR_RD0501_01_f_2017_39				
Comment Code					
V2 : Remove the wild growth other than native grasses from the levee slopes.					
Inspector Comment					
Heavy blackberry growth along toe should be removed to allow inspection and access to toe. LMA reports ditch near toe inhibits ability to mow.

Heavy blackberry growth along toe, possibly over fence, should be removed to allow inspection and access to toe.

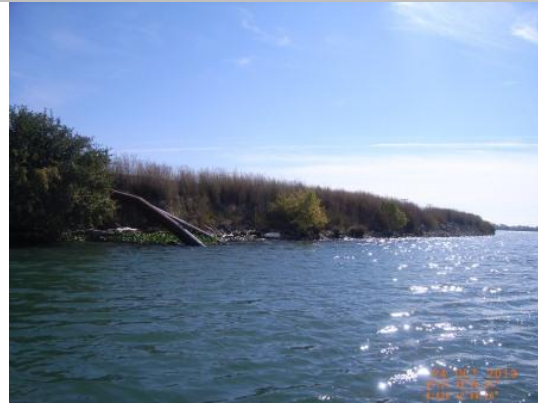
Photo 1 of 1 : SP\_2018\_RD0501\_170\_1\_20180305\_00001.jpg

LM Start	1.10	Rating **	M	Issue No.	1
LM End	1.17	Issue Type +	Ma	Location *	WS
Category	Supplemental			GPS Latitude/Longitude	
				Start	End
Item	2015 USACE Erosion Survey, DRAFT			38.199128 °	38.200146 °
				-121.655881 °	-121.655638 °
DWR ID	DWR_RD0501_02_f_2016_1				
Comment Code					
Inspector Comment					
2005 - Large vertical sections due to wave wash. New stone dumped on the bank with exposed geotextile. Cohesive toe has thin weak stratigraphic unit that is washing out. 2006 - Partially repaired, but 100 ft in the middle of the reach has exposed filter fabric and stone riprap is gone. 2010 - Site extended downstream to include new erosion pocket. 2015: No observed changes. [2015 Site ID: CHS_15-9_L]

USACE 2013 Photo #1

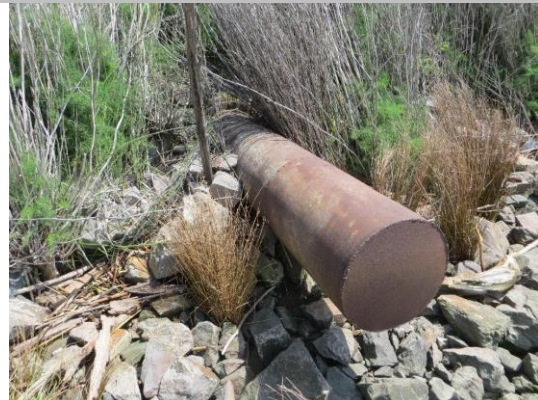
Photo 1 of 3 : UCIP\_SP\_2018\_44753\_73955.jpg

LM Start	1.25	Rating **	M	Issue No.	27
LM End	1.25	Issue Type +	Ma	Location *	
Category	Supplemental			GPS Latitude/Longitude	
				Start	End
Item	DWR UCIP LMA Responsibility			38.201143 °	38.201143 °
				-121.655169 °	-121.655169 °
DWR ID					
Comment Code					
Inspector Comment					
FS_ID:44753					
DS_ID:21085					
EP_NO: N/A					
Repair Type: Non-Urgent					
Crossing Status: Found					
UCIP Comments: Hole rusted through pipe on WS end. Pipe abandoned and should be done so properly.					
FIELD_STRUCT_DESC: *ABANDONED* 20-inch coated steel gravity drainage pipe through the levee, 15.5 feet below the crown. Pipe exposed along the waterside (WS) slope. Steel plate welded over end. [Additional Reference(s): USACE Sacramento O&M Manual 105, April 1959, (HLM 1.4)].					
FS Date: 4/23/2015

20-inch pipe with welded steel plate over end on WS toe.

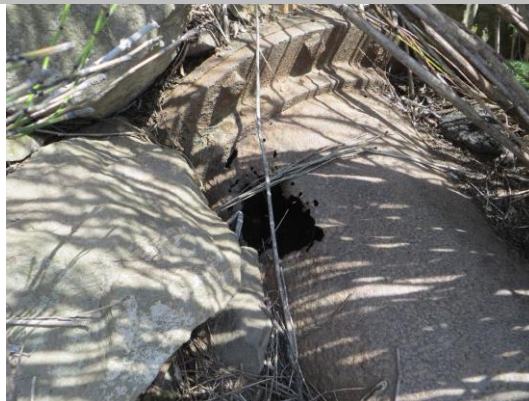
Photo 2 of 3 : UCIP\_SP\_2018\_44753\_73954.jpg

Hole in pipe at WS toe.

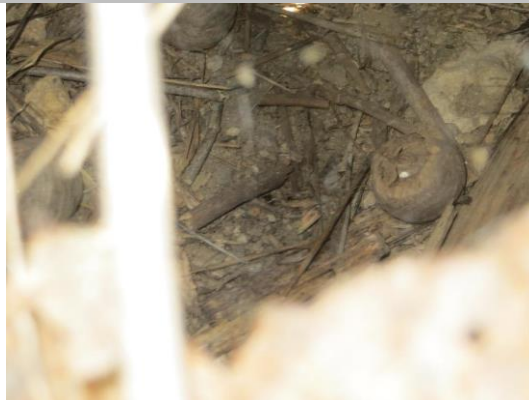
Photo 3 of 3 : UCIP\_SP\_2018\_44753\_73953.jpg

Inside hole in pipe at WS toe.

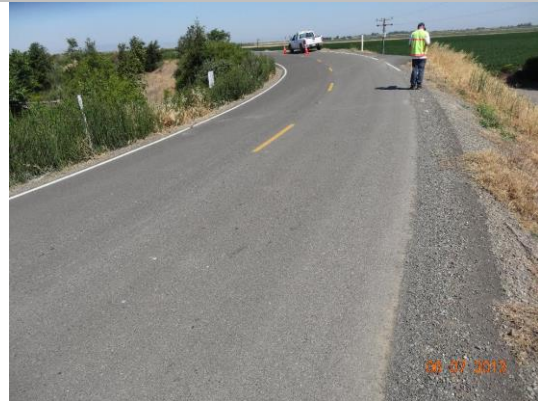
Photo 1 of 3 : UCIP\_SP\_2018\_40489\_33358.jpg

FS\_ID:40489  
DS\_ID:21042  
EP\_NO: 15477  
Repair Type: Non-Urgent  
Crossing Status: Found  
UCIP Comments: Stacey Boyd, LMA superintendent for RD0501, confirmed the removal and replacement of existing crossing under new permit no. 18811. New crossing will be a 30-inch diameter discharge pipe above the design flood plane. Construction will start soon. Update record once the project is completed. Dense vegetation on both waterside and landside. Recommend removing vegetation along pipe alignment to conduct proper inspection of structure and appurtenances. FIELD\_STRUCT\_DESC: 42-inch steel drainage discharge pipe through the levee, 6.5 feet below the crown. Siphon breaker on the waterside (WS) slope. Pump on the landside (LS). Pipe exposed along both slopes. (Plans to replace two pipes with two 36-inch discharge pipes through the levee authorized under Permit No. 15477, 1990 - Reclamation District No. 501 [RD0501]). Permit does not match this crossing. Recommend deletion of permit. [Additional Reference(s): DWR Levee Log, 2005. USACE Sacramento O&M Manual 105, April 1959, (HLM 2.0)].

Overview of crown, looking downstream.

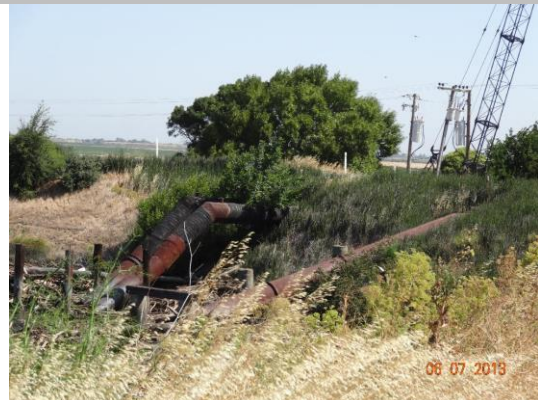
Photo 2 of 3 : UCIP\_SP\_2018\_40489\_33359.jpg

One 42-inch steel pile with siphon break on waterside slope.

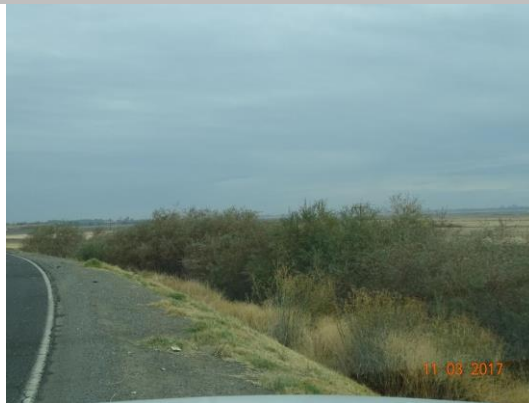
Photo 1 of 1 : SP\_2018\_RD0501\_171\_28\_20180305\_00001.jpg

LM Start	1.48	Rating **	M	Issue No.	28
LM End	1.48	Issue Type +	Ma	Location *	LS
Category	Earthen Levee			GPS Latitude/Longitude	
				Start	End
Item	Trim / Thin Trees			38.244293 °	38.244293 °
				-121.657843 °	-121.657843 °
DWR ID	DWR_RD0501_03_f_2017_28				
Comment Code					
T2 : Thin trees to allow visibility of the ground and room to flood fight.					
Inspector Comment					
Trim/thin willows to allow inspection and access to landside slope and toe.

Trim/thin willows to allow inspection and access to landside slope and toe.

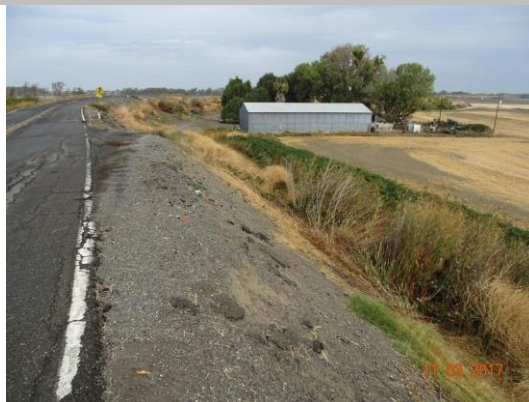
Photo 1 of 1 : SP\_2018\_RD0501\_171\_29\_20180305\_00002.jpg

LM Start	1.56	Rating **	M	Issue No.	29
LM End	1.56	Issue Type +	Ma	Location *	LS
Category	Earthen Levee			GPS Latitude/Longitude	
				Start	End
Item	Vegetation			38.245445 °	38.245445 °
				-121.658035 °	-121.658035 °
DWR ID	DWR_RD0501_03_f_2017_29				
Comment Code					
V2 : Remove the wild growth other than native grasses from the levee slopes.					
Inspector Comment					
Remove berry vines at landside toe to allow inspection and access.

Remove berry vines at landside toe to allow inspection and access.

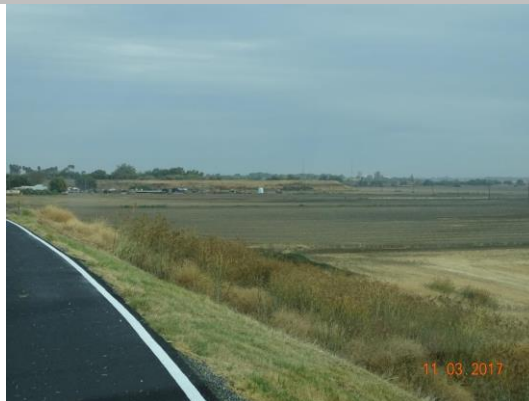
Photo 1 of 1 : SP\_2018\_RD0501\_171\_30\_20180305\_00003.jpg

LM Start	1.89	Rating **	M	Issue No.	30
LM End	1.89	Issue Type +	Ma	Location *	LS
Category	Earthen Levee			GPS Latitude/Longitude	
				Start	End
Item	Vegetation			38.249428 °	38.249428 °
				-121.656310 °	-121.656310 °
DWR ID	DWR_RD0501_03_f_2017_30				
Comment Code					
V2 : Remove the wild growth other than native grasses from the levee slopes.					
Inspector Comment					
Remove/manage landside vegetation and berry vines to allow inspection and access to slope and toe.

Remove/manage landside vegetation and berry vines to allow inspection and access to slope and toe.

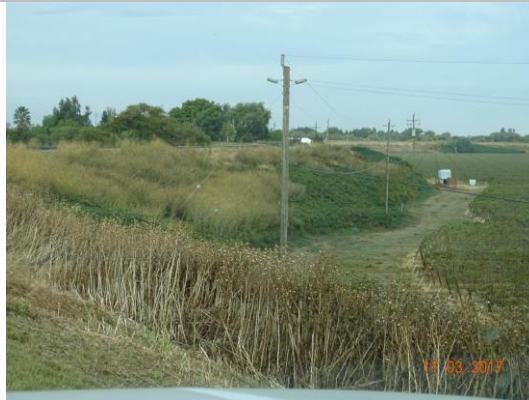
Photo 1 of 1 : SP\_2018\_RD0501\_171\_34\_20180305\_00005.jpg

LM Start	4.47	Rating **	M	Issue No.	34
LM End	4.80	Issue Type +	Ma	Location *	LS
Category	Earthen Levee			GPS Latitude/Longitude	
				Start	End
Item	Vegetation			38.277918 °	38.281507 °
				-121.637670 °	-121.641595 °
DWR ID	DWR_RD0501_03_f_2017_34				
Comment Code					
V2 : Remove the wild growth other than native grasses from the levee slopes.					
Inspector Comment					
Remove berry vines on landside slope and toe to allow inspection and access.

Remove berry vines on landside slope and toe to allow inspection and access.

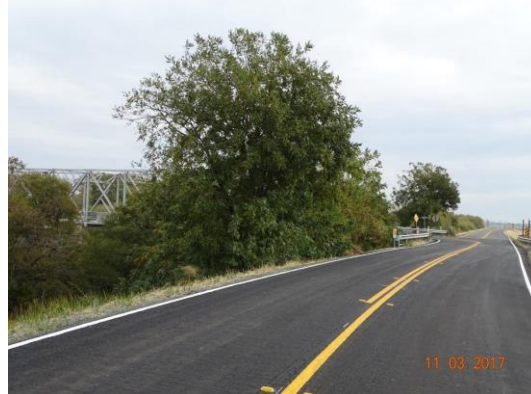
Photo 1 of 1 : SP\_2018\_RD0501\_171\_40\_20180305\_00008.jpg

LM Start	6.14	Rating **	M	Issue No.	40
LM End	6.14	Issue Type +	Ma	Location *	WS
Category	Earthen Levee			GPS Latitude/Longitude	
				Start	End
Item	Trim / Thin Trees			38.291563 °	38.291563 °
				-121.632068 °	-121.632068 °
DWR ID	DWR_RD0501_03_f_2017_40				
Comment Code					
T1 : Trim trees to at least five feet above ground level.					
Inspector Comment

Trim/thin trees on waterside to allow inspection and access.

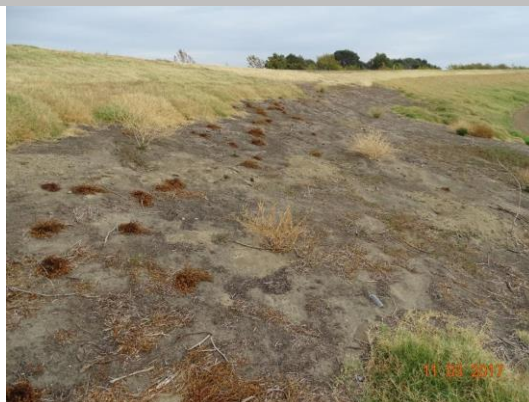
Photo 1 of 1 : SP\_2018\_RD0501\_171\_39\_20180305\_00007.jpg

LM Start	6.61	Rating **	M	Issue No.	39
LM End	6.61	Issue Type +	Ma	Location *	LS
Category	Earthen Levee			GPS Latitude/Longitude	
				Start	End
Item	Animal Control			38.290313 °	38.290313 °
				-121.623785 °	-121.623785 °
DWR ID	DWR_RD0501_03_f_2016_39				
Comment Code					
A1 : Exterminate rodents and backfill and compact or grout burrows.					
Inspector Comment					
Evidence of significant rodent activity at this location. Exterminate the rodents and backfill holes.

Evidence of significant rodent activity at this location. Exterminate the rodents and backfill holes.

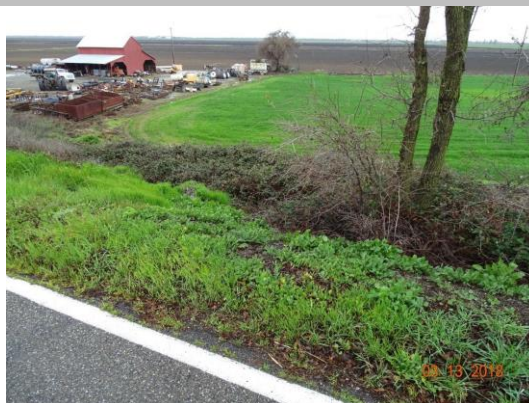
Photo 1 of 1 : SP\_2018\_RD0501\_172\_11\_20180313\_00030.jpg

LM Start	0.84	Rating **	M	Issue No.	11
LM End	0.84	Issue Type +	Ma	Location *	LS
Category	Earthen Levee			GPS Latitude/Longitude	
				Start	End
Item	Vegetation			38.274615 °	38.274615 °
				-121.602718 °	-121.602718 °
DWR ID	DWR_RD0501_04_f_2017_11				
Comment Code					
V2 : Remove the wild growth other than native grasses from the levee slopes.					
Inspector Comment					
Remove thick blackberries at landside toe to allow inspection and access.

Thick blackberries should be removed.
